Manhole Inspection Summary

Manhole # S65S__002MH

Insp Date: **3/6/08 10:56 AM**

Location Address: **1562 Elrino St.**

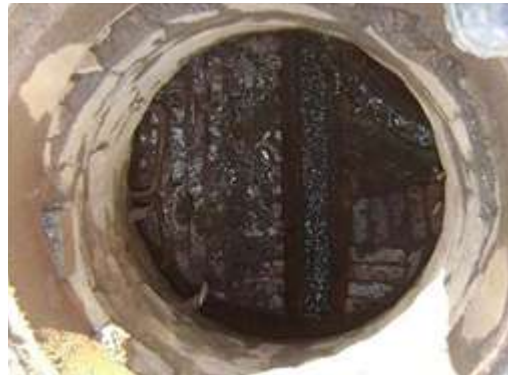
Top View

Condition: ☐ Sound ☐ Cracked ☐ Root Intrusion ☒ **Loose Brick** ☒ **Deteriorated**

Infiltration: ☐ None ☒ **Joint** ☐ Cracks ☒ **Mortar** ☐ Roots ☐ Wall
